## Simple Things...

**FlatRaters Garage***Quick and Expensive Repairs***1991 S10 Pickup****4.3 L V6****178,000 Miles****1) Runs Rough****2) SES Lamp On**

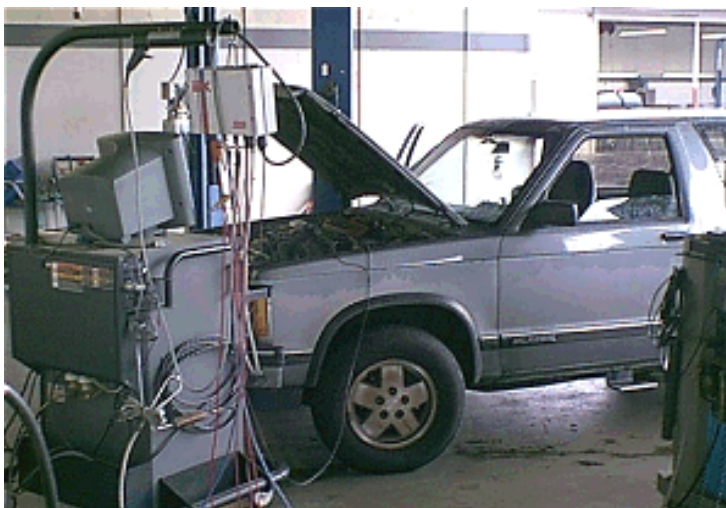
What a pile this is.... You can't see it well in this picture, but the paint is peeling everywhere, the interior is junk, and it runs terrible. I took it for a blast down the street before making my way to my service bay. When accelerating, it would fall **hard** on its face as if fuel pressure/volume was very low. **I also noticed that the motor mounts were wasted...**

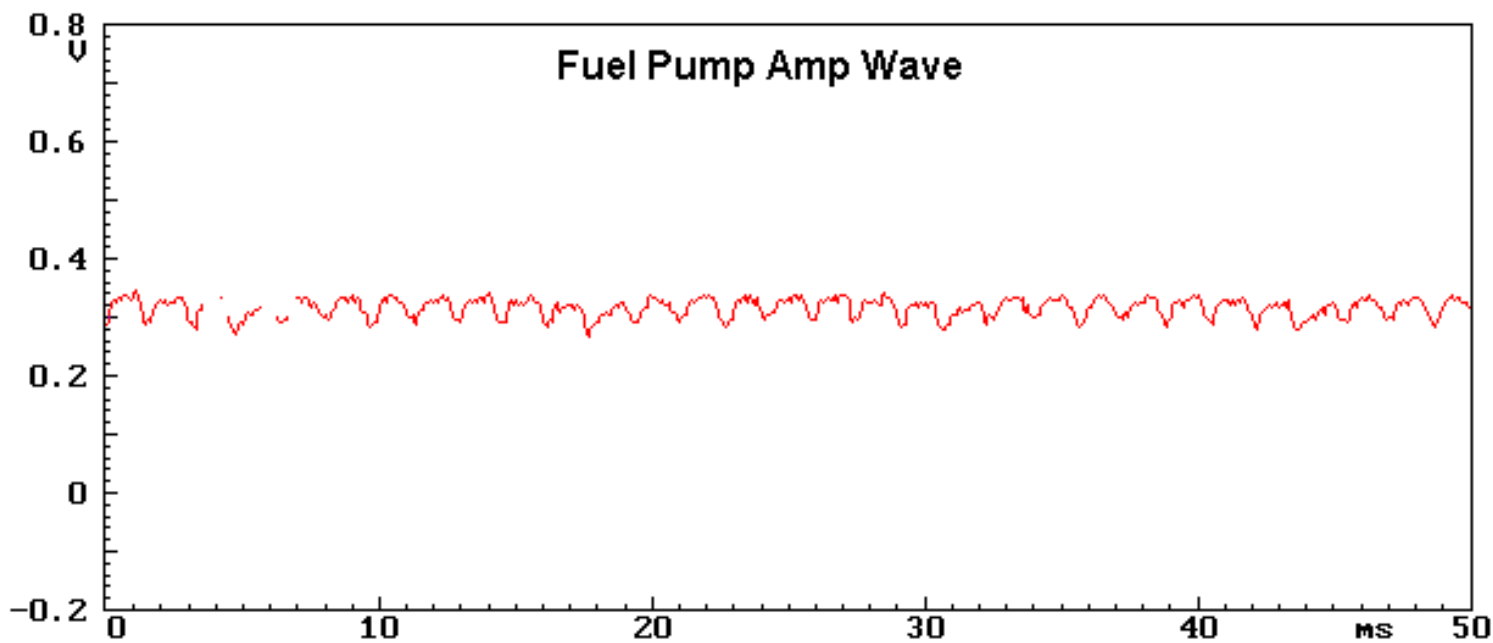
Feeling sure that fuel pressure was low, I skipped the scanner and went straight for a fuel pump amp wave. Normal amp draw would be 3 to 4 amps for this TBI fuel system.

Oops, not what I expected.... Time to track down the Tech 1 and see what kind of data we have.... I found these codes stored:

- **DTC 22** Throttle Position Sensor signal voltage low
- **DTC 34** Manifold Pressure Sensor voltage low (high vacuum)
- **DTC 45** Oxygen Sensor -- Rich exhaust indicated

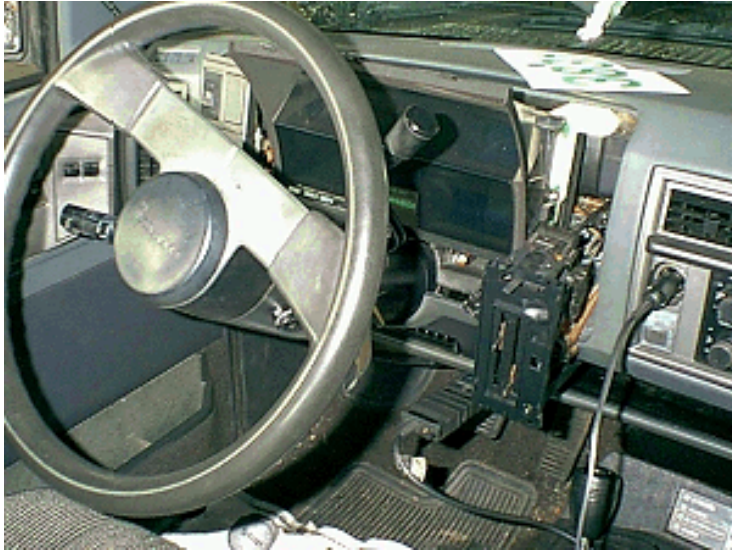
At this time, I started to look around inside more carefully.... As you can see, the dash is torn apart. There were aftermarket parts boxes laying on the floor.

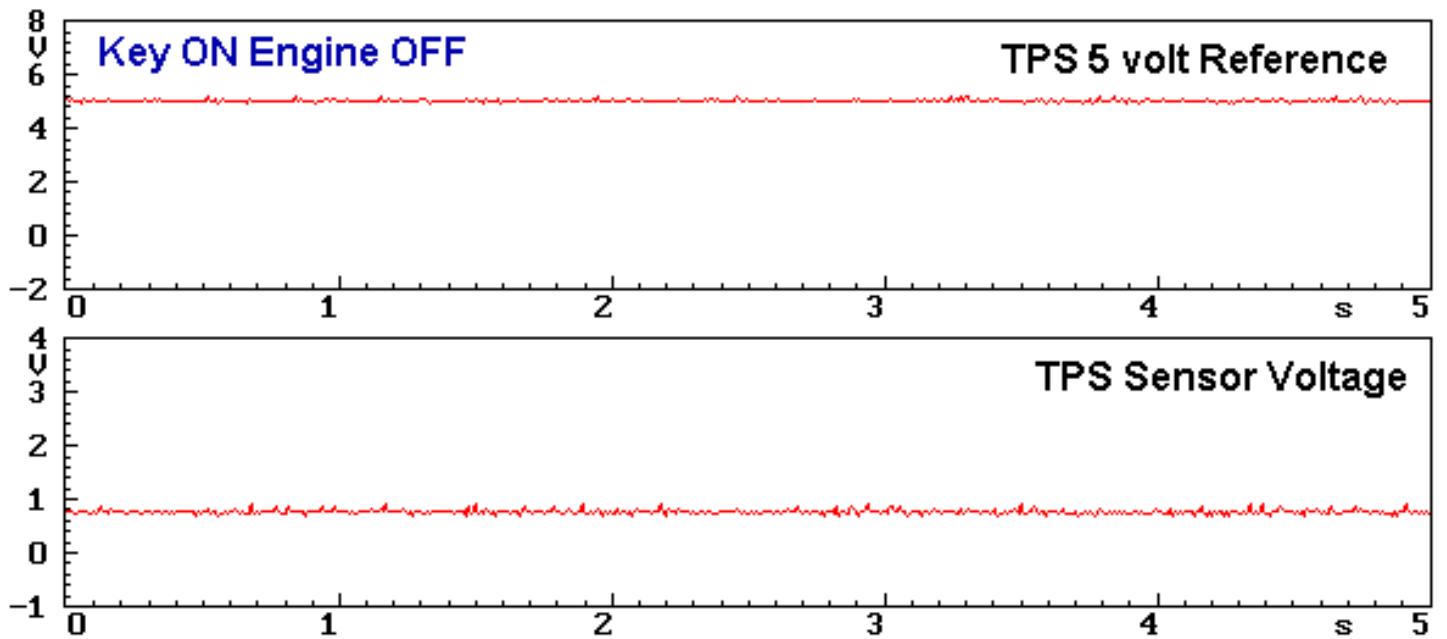
The engine wiring harness is very difficult to visually inspect with much of it sandwiched between the firewall and the heads, but after searching for quite a while, all I could find was a heater case bolt (sharp) lightly pushing against the harness as it came through the firewall from the passenger compartment. I pulled the harness away from the bolt, grabbed my scope, and took these shots

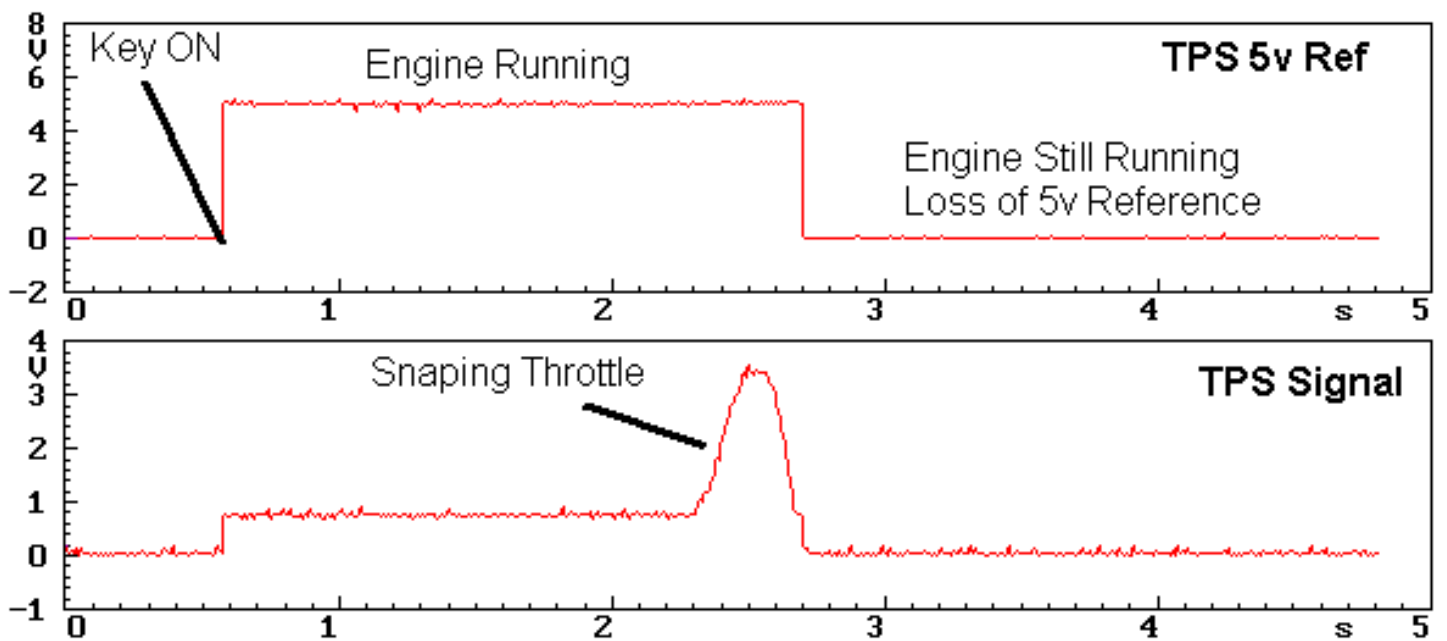
With the above image, I did not have to power brake the engine to cause the failure. All I did was snap the throttle with the transmission in park. I very gently pulled the harness (near the TPS) forward again and then when I released it, got the following

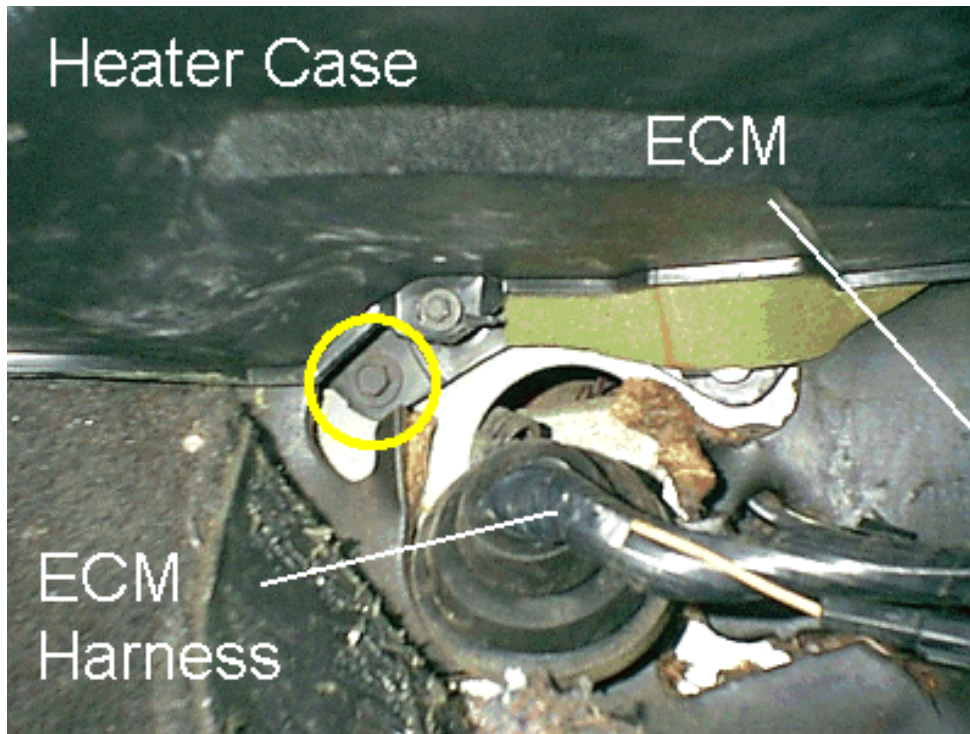
I spent a great deal of time trying to see the wiring behind the heads and above the transmission, looking for where the harness might be grounding out to no avail. The only possible point was here.

As the ECM harness goes through the firewall, it crosses over the HVAC case bolt that sticks out into the other side (holding the HVAC case to the body).

I found the HVAC case bolt protruding into the harness. Assuming it was grounding out the 5v reference wire, I moved the harness safely away.

The actual problem with the 5v circuit was that under the right conditions, it would go open somewhere between the ECM and the TPS. Most likely, the HVAC bolt had protruded through the harness and partially cut the wire so that it could not carry a load at times. Since it was next to impossible to dig out the harness to verify, I just ran a completely new wire from the ECM to the TPS/MAP.

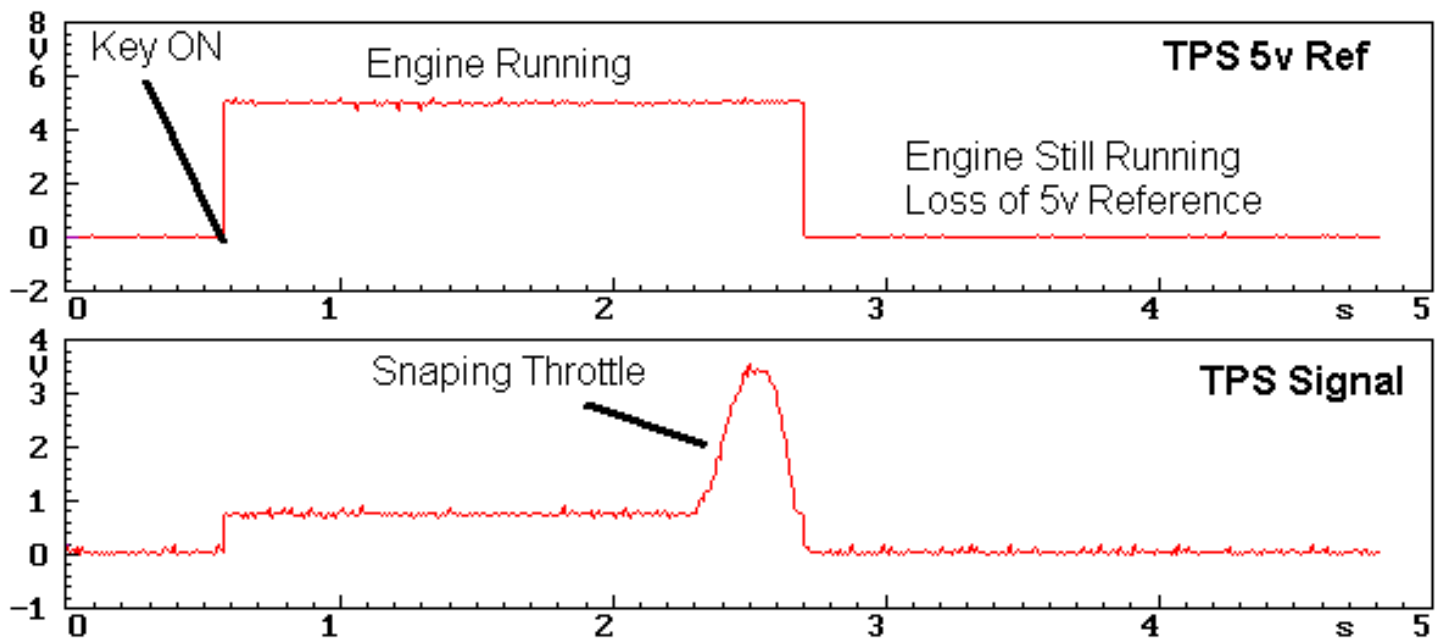
Now with the harness away from the bolt and (as far as I could see) no other grounding problems, I was surprised to see that the problem was still present.

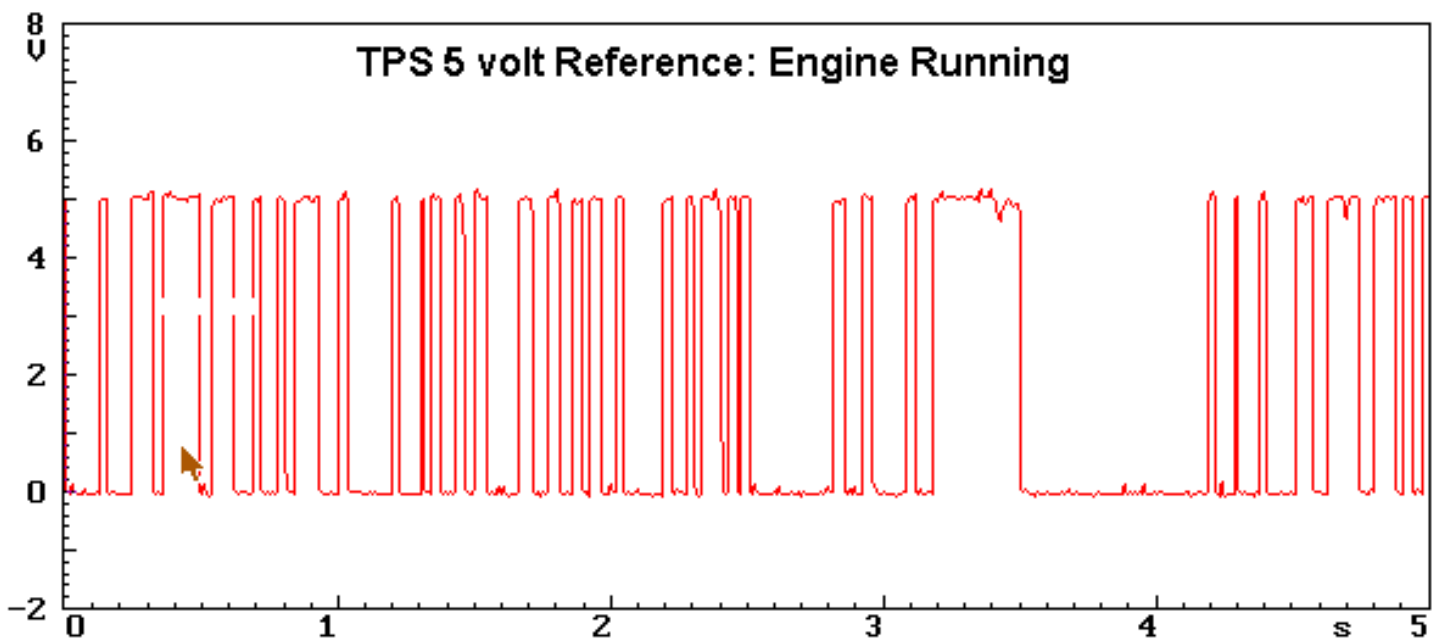
As I sat there perplexed and pondering my navel, the 5v signal started doing this while the engine was just sitting there idling...
