# WELLS Counter Point

Volume 11 Issue 3, Summer 2007

## The Triangle Of Doom

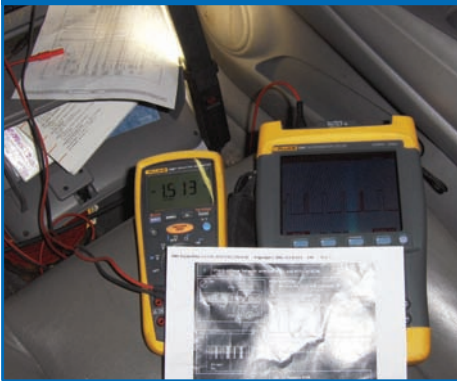
Figure 1: Checking voltage between HTE+ and HTE-

Following the Toyota flowchart and checking voltage between HTE + and HTE - of the ECM, I came up with a reading of 1.49 volts and a waveform that matched Toyota's example (Figure 1). The Toyota flowchart then states that the ECM should be replaced. I've been around awhile, and it's hard for me to swallow replacing an ECM without first checking every sensor and component that is associated with it. I think that flowcharts should be renamed "trouble charts" because in many cases that's what you will find yourself in.

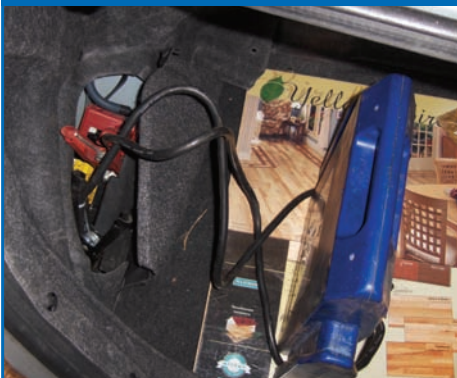
Figure 2: Installing battery pack on AGM battery

Since the flowchart did not make sense to me, I decided to get back to the basics and test the 12-volt battery. I found that the vehicle's absorbed glass mat (AGM) 12-volt battery was below specification. A word of caution is in order concerning this battery. Be careful when charging the AGM 12-volt battery because it can and will be damaged if the charging current surpasses 3.5 amps.

As you can see in Figure 2, I installed a battery pack and retested the ECM just to

verify I was testing with the correct voltage. While retesting, I captured the identical meter and scope readings, with one difference: the DTC P1636 was gone.

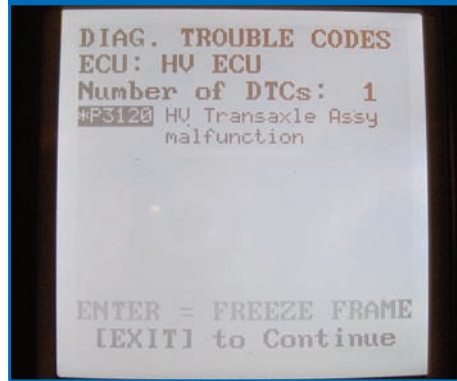
Figure 3: DTC P3120 HV Transaxle Assy Malfunction

DTC P3002 (HV Serial Communication Abnormality) deals with a communication problem to the HV ECU. This DTC was coming back even with the 12-volt AGM battery fully charged. I knew this vehicle now had a hard problem in the HV system but I proceeded to check the other DTCs. P3120 (HV Transaxle Assembly Malfunction) (Figure 3) confirmed the DTC HV P3002, but I had to look into the sub system DTC 253 Generator Resolver Inter-Phase Short. The sub system DTC lead me to the cause of my HV problem. The MG had a shorted winding that I confirmed with my megohm meter (Figure 4 - Bad & Figure 5 - Good.)

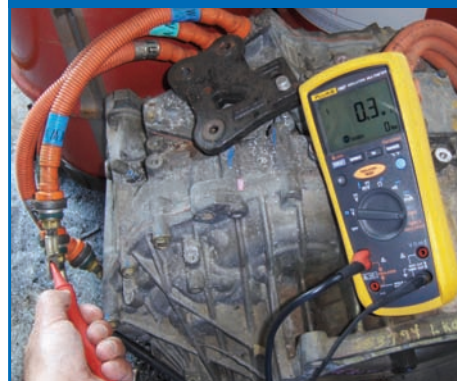
Figure 4: Hybrid transaxle with shorted MG windings

I was confident with my diagnosis and recommended replacing the salvage yard transaxle. We waited three weeks for the salvage yard to locate a replacement. When it arrived, we made sure to check the unit for visible damage and/or shorted windings. The transaxle was replaced for the second time, test driven and checked for DTCs, all without any problems. The Prius was ready to be returned to the customer, minus the Triangle of Doom.

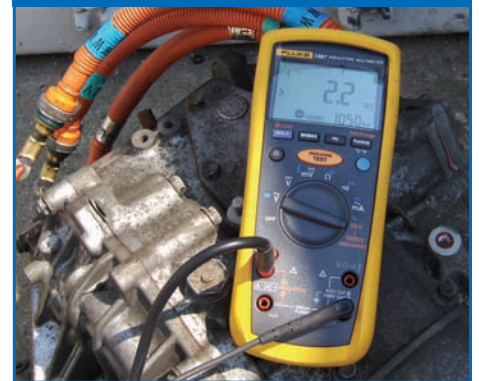
Figure 5: Second transaxle with good MG windings
