GM No-Crank in vehicles with Vehicle Anti-Theft System (VATS)

Inoperative Power Seats/ 1996 and Newer GM S-Series Trucks

Trouble Code P1520 **Ford Contour 6-Cylinder Duratech**

Inoperative ABS/ 1997 Buick LeSabre

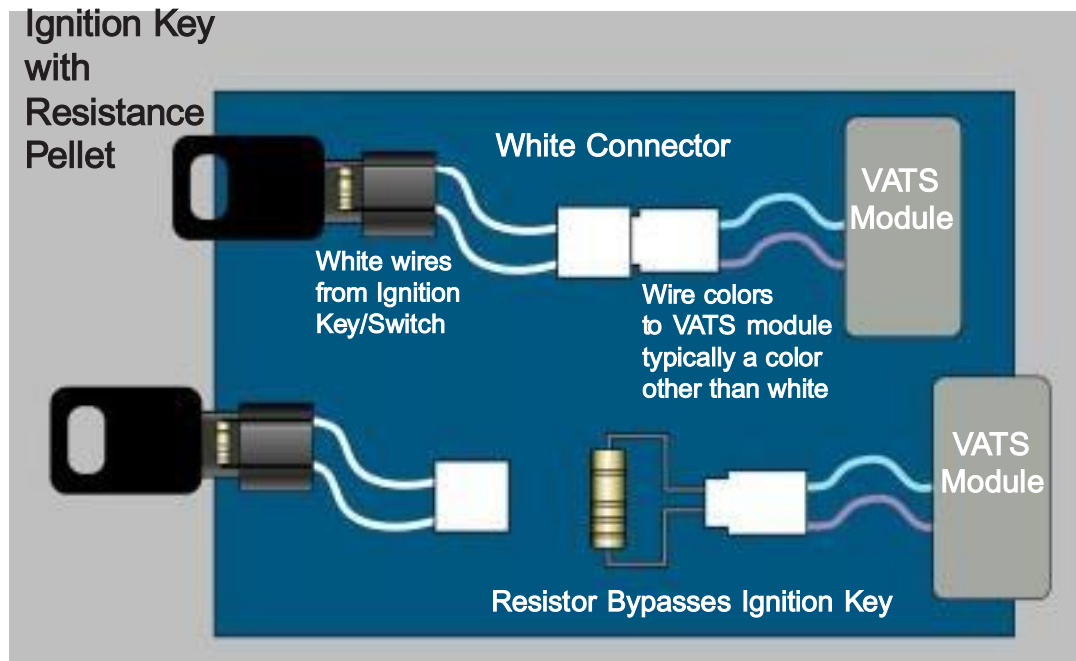
Experience suggests that VAT ignition key failures are less common than no-cranking conditions caused by switch/harness failures.

- Remove the ignition key and measure the resistance of the pellet in the key.
- Drop the steering column bezel and disconnect the white wire connector.

- Connect your sensor simulator across the terminals of the harness connected to the VATS module and “dial in” a resistance equal to the key pellet resistance, or simply insert a fixed resistor of the correct value.

This bypasses the key/harness and, in many instances, it will allow you to start the vehicle and drive it into the shop.

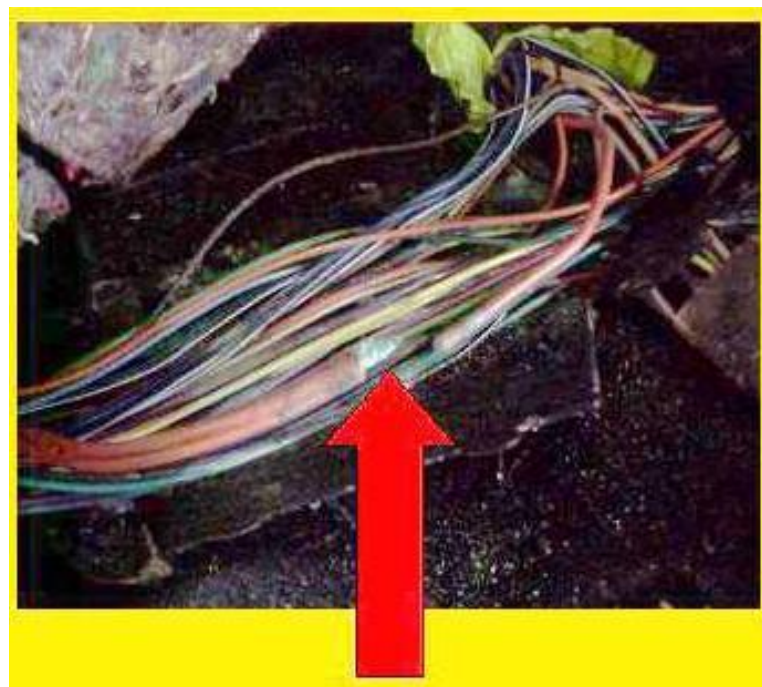
Vehicle Problem: Inoperative power seats (either one or both).

Diagnostic Approach: Test the main power terminal at the seat switches. Then try to operate the seats while performing a voltage drop test between the main power source and seat switch main power terminal. (Just because the main power terminal is hot without a load applied doesn't mean that it won't fail when actually try to operate the seats.)

Diagnostic Tip: Check for corroded wiring beneath the driver's side carpeting in the area in front of the seat where the driver puts his wet feet! Water from the driver's shoes eventually soaks through the carpeting, resulting on wire corrosion and a big old voltate drop!

Repair Solution: Repair the wiring (solder and apply heat shrink tubing), and then insulate the harness to prevent a further occurrence of the same problem.

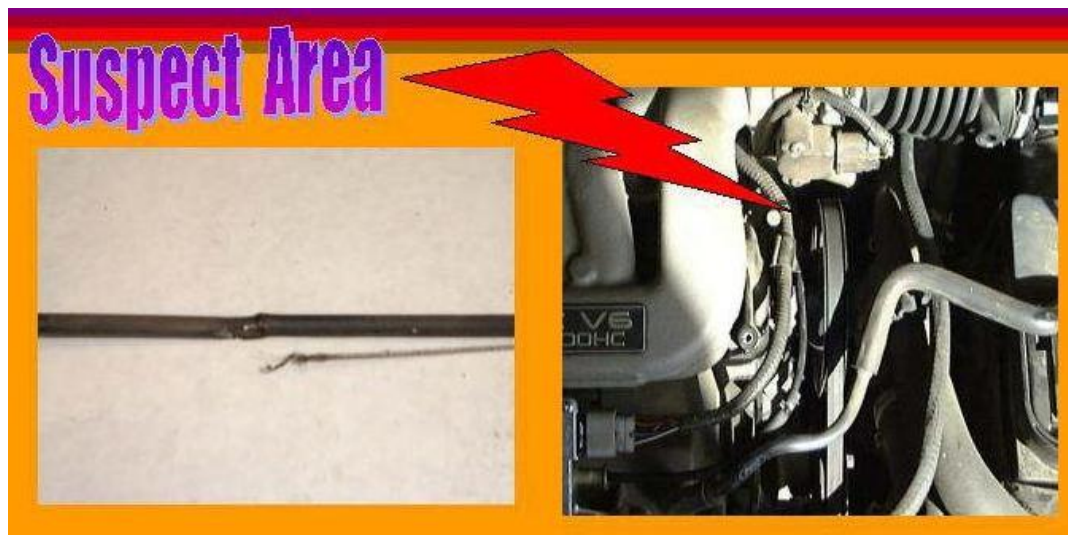
Vehicle Problem: DTC P1520 stored (Intake Manifold Runner Control Circuit Fault).

Other Clues: Lack of power and reduced fuel economy. (The high RPM intake manifold runners don't open.)

The **Intake Manifold Runner Control (IMRC)** motor cable is routed beneath the plastic shield over the drive belt pulley. Vibration can result in a "rub through" condition at the cable. When this happens, the cable can come loose from its plastic hold down and come in contact with the drive pulley. Ouch. The pulley eventually cuts the cable in two.

Repair Procedure: Replace and IMRC motor and cable assembly. Secure the cable to prevent a reoccurrence.

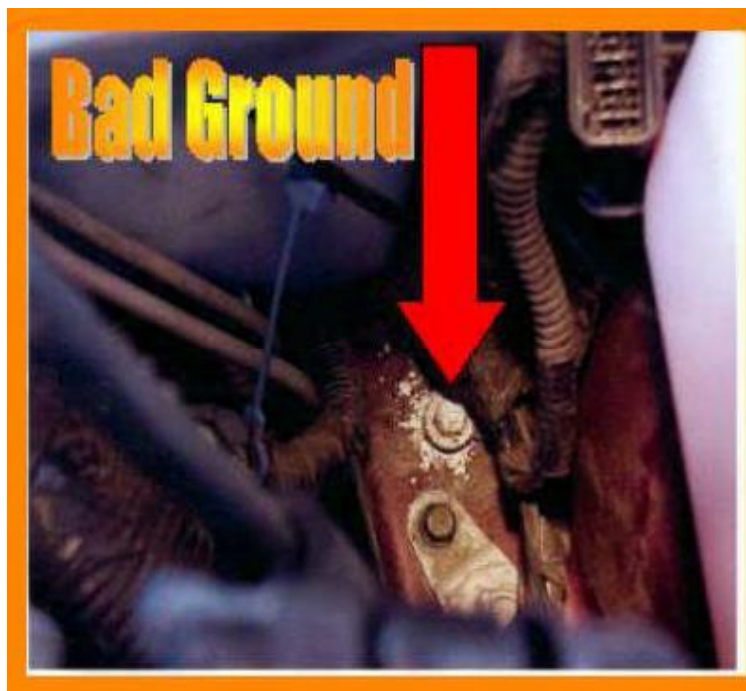
Vehicle Problem: Inoperative ABS

Diagnostic Approach: Check the ground connection shown in our photo for a voltage drop. The ground attachment is located directly below the windshield washer reservoir.

Any spillage that occurs when refilling the bottle soaks the connection, resulting on corrosion and a ground side voltage drop.

This is the ground for the ABS pump!

Repair Solution: Remove the washer bottle. Perform a voltage drop test, or simply remove the ground bolt and thoroughly clean all metal-to-metal mating surfaces to restore a good ground.

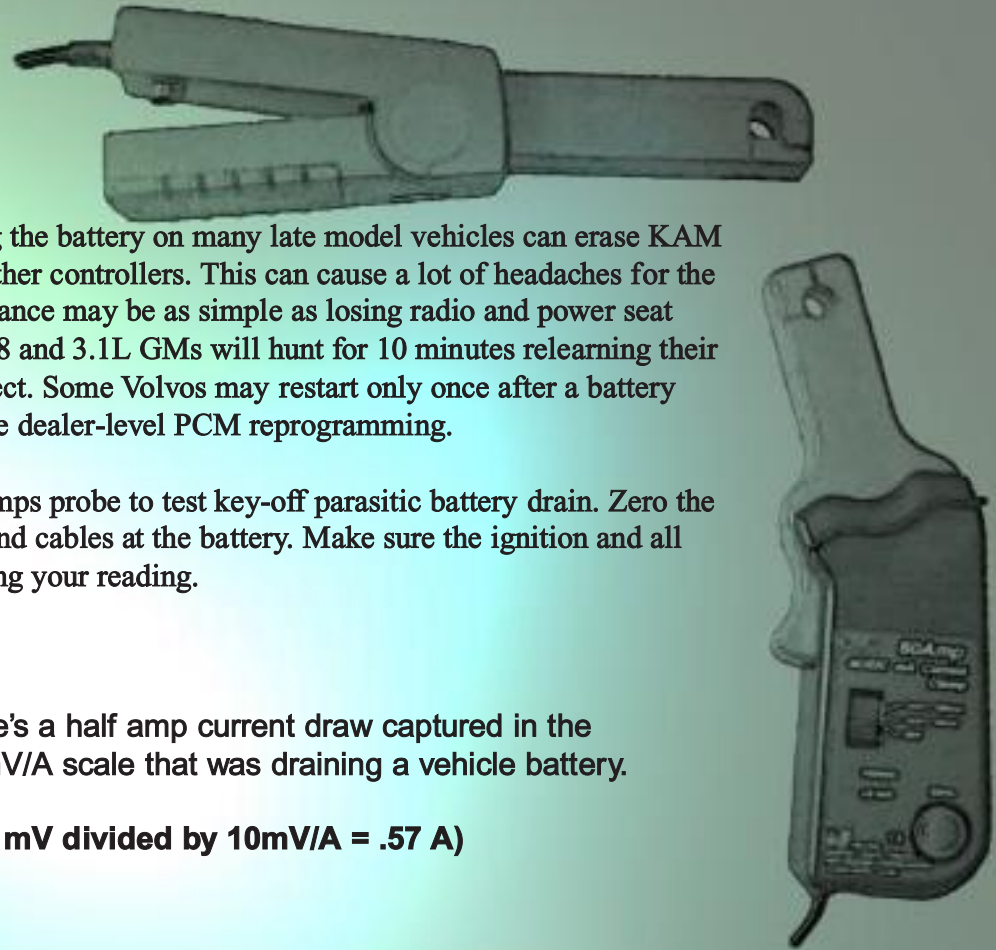
Here's a half amp current draw captured in the 10mV/A scale that was draining a vehicle battery.

(5.7 mV divided by 10mV/A = .57 A)

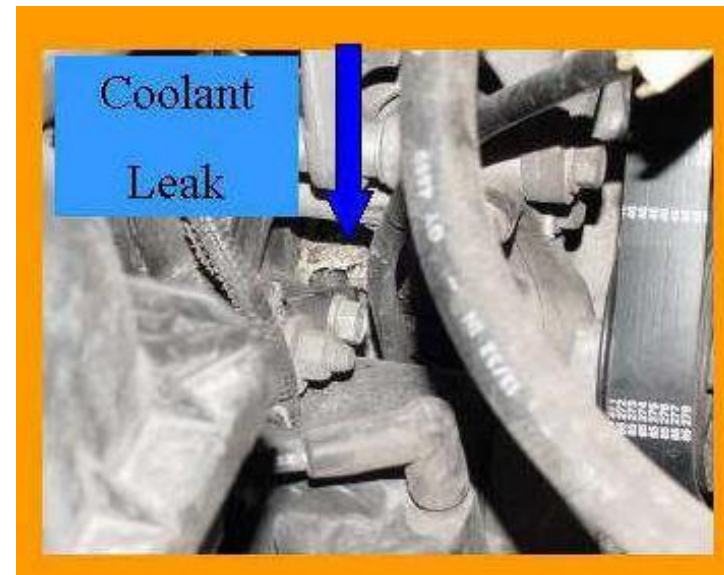
Jeep 5.8L Misfire/No-Start

Vehicle Problem: Erratic ignition system operation including misfire and possible no-start conditions.

Clues: Look for telltale signs of antifreeze at the timing cover and ignition coil.

Diagnostic Approach: The coolant leak blows around and eventually finds its way to the ignition coil. The coolant causes a poor contact at the ignition coil primary circuit connection, resulting in the misfire condition.

Repair Procedure: Correct coolant leak and clean the ignition coil electrical contacts to remove residual antifreeze and corrosion.

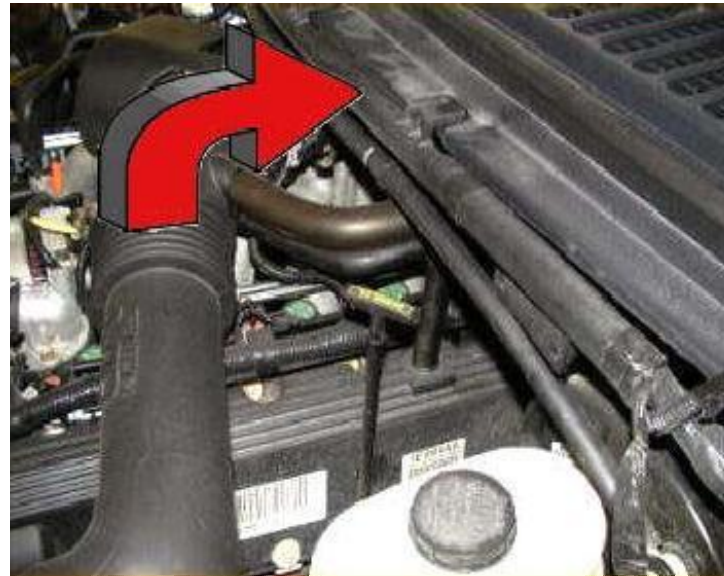
Ford Coil-on-Plug (COP) P0304 or P0308 DTCs

Vehicle Problem: OBD II DTC P0304 (Misfire Cylinder #4) and/ or P0308 (Misfire Cylinder #8) on Ford COP ignitions.

If you have a **P0308**, check the cowl weatherstrip. A water leak from the cowl/hood seal may be leaking directly onto the #4 COP.

If you have a **P0304**, check for leakage from the heater hose connection. Same problem, different leak.

Repair Procedure: Remove the cowl weatherstrip and clean out any debris. Then use RTV to attach the weatherstrip to the cowl to prevent future leaks.

If the code is a P0304, repair the heater hose leak.
