DT466E Fuel System

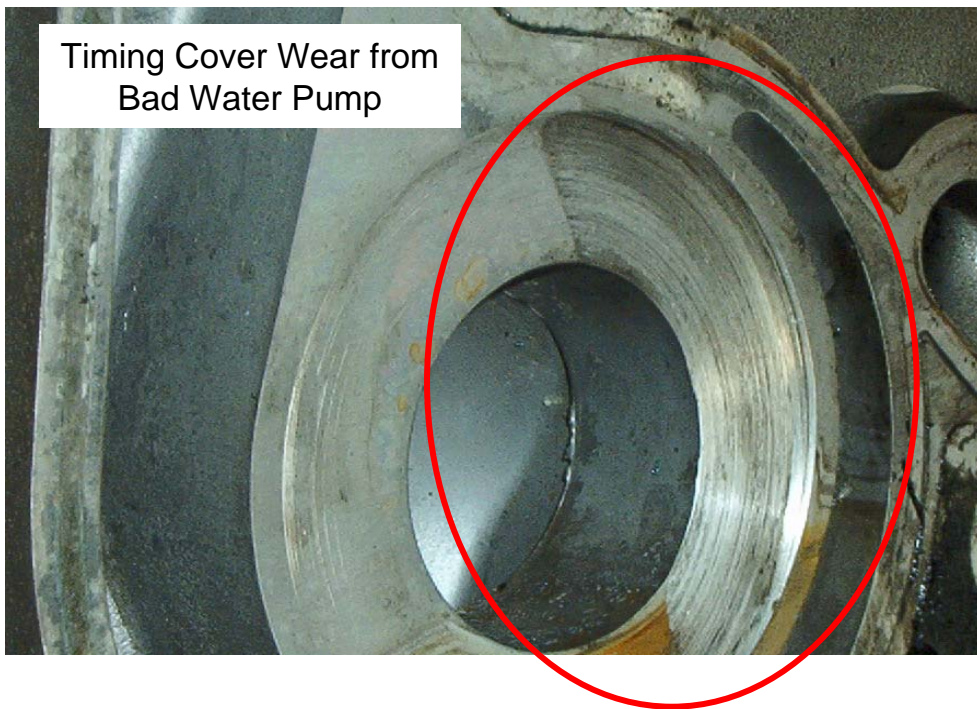
DT466 has had troubles with water pump bearings failing and boring a hole through the timing cover, ruining it. It is a good idea to remove the serpentine belt at LOF and feel the water pump bearing for play. There is a revised water pump bearing used since October 2000 to combat this. If you have old stock water pumps on the shelf, it is wise to replace them. Timing cover wear is allowed to reach 1/8", after which timing cover replacement is needed.

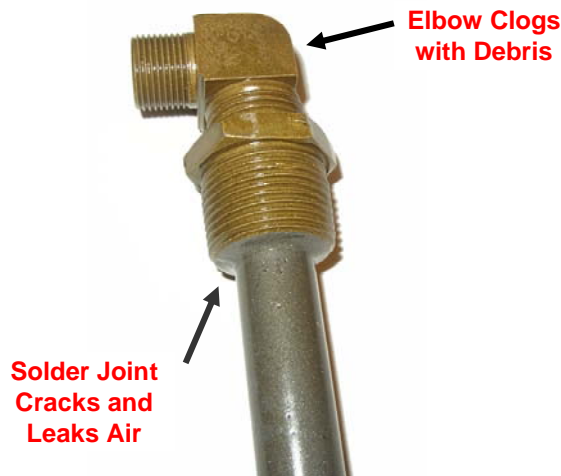
The dip tube in the fuel tank has several inherent problems.
