GM No-Crank in vehicles with Vehicle Anti-Theft System (VATS)

Inoperative Power Seats/ 1996 and Newer GM S-Series Trucks

Trouble Code P1520 **Ford Contour 6-Cylinder Duratech**

Inoperative ABS/ 1997 Buick LeSabre

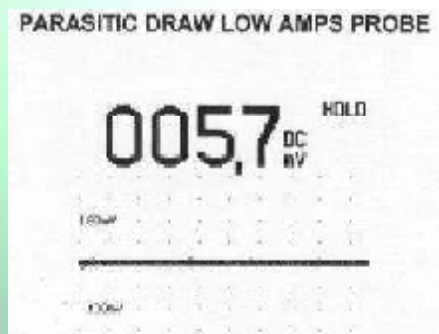
Here's a half amp current draw captured in the 10mV/A scale that was draining a vehicle battery.

(5.7 mV divided by 10mV/A = .57 A)
