## Simple Things...

**FlatRaters Garage***Quick and Expensive Repairs***1991 S10 Pickup****4.3 L V6****178,000 Miles****1) Runs Rough****2) SES Lamp On**

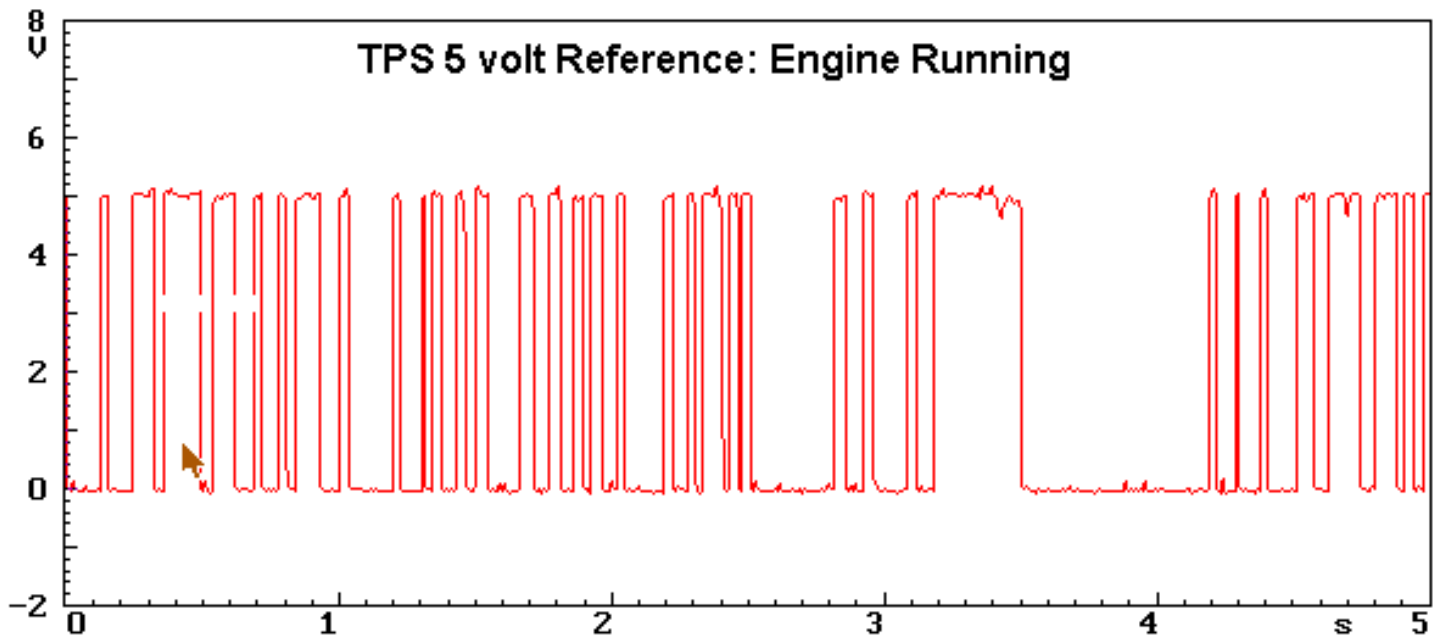
With the above image, I did not have to power brake the engine to cause the failure. All I did was snap the throttle with the transmission in park. I very gently pulled the harness (near the TPS) forward again and then when I released it, got the following

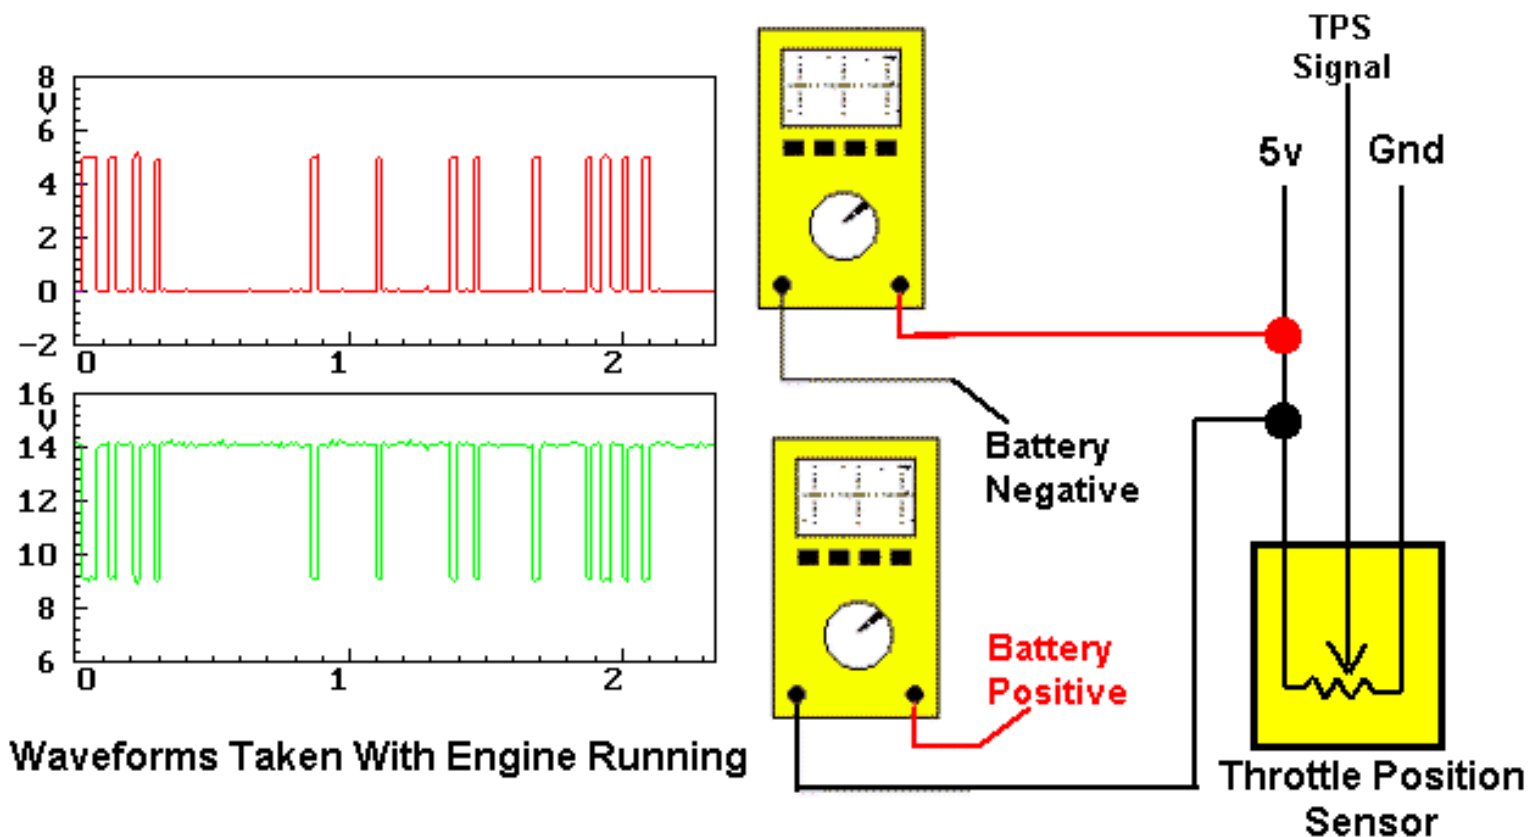
Ya know.... What we need here is an easy way to test whether we're losing the 5v reference or whether it is being grounded out. Does this do it? Why or why not?

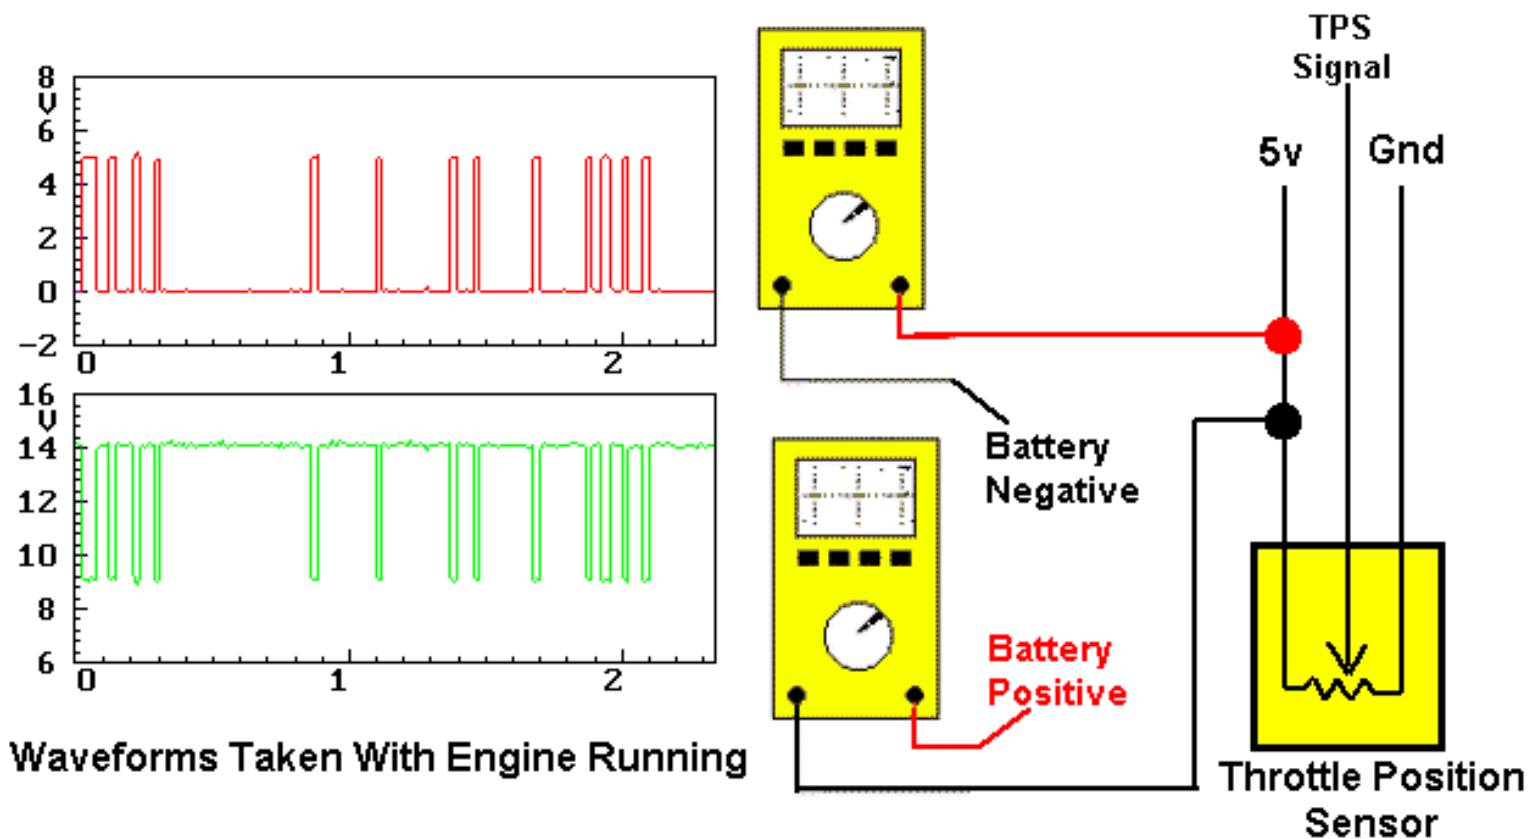
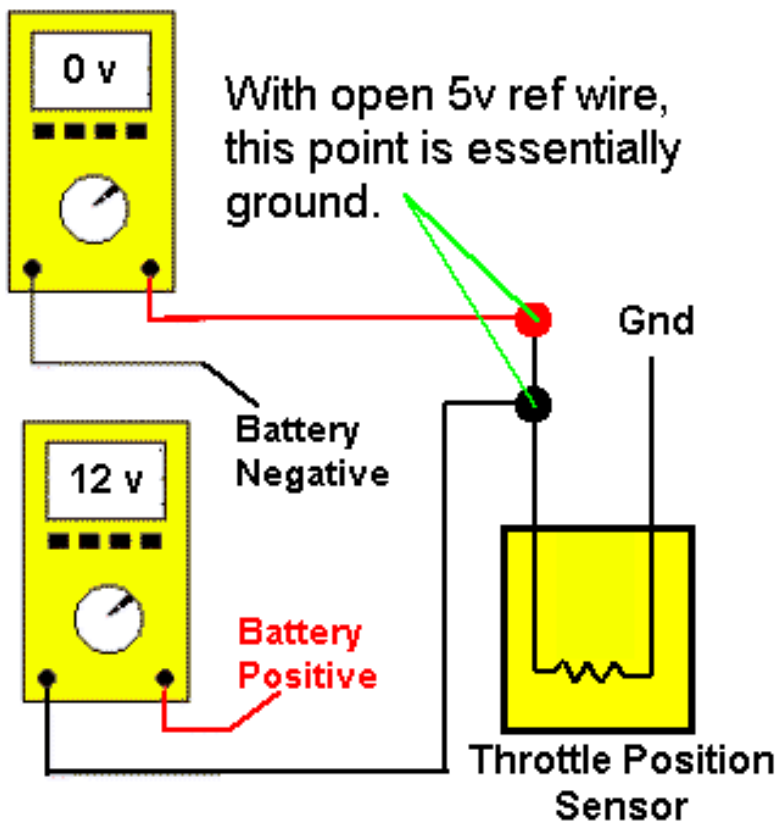
Now one thing I did for fun before I repaired the wiring and returned the ECM was this.....

I figured it would make this study a little more fun. Consider that whether the 5v circuit (above) becomes grounded or goes open, in a sense, it is always ground to the meter.

Here with the 5v wire OPEN, the circuit is also OPEN and therefore the test point is essentially ground.

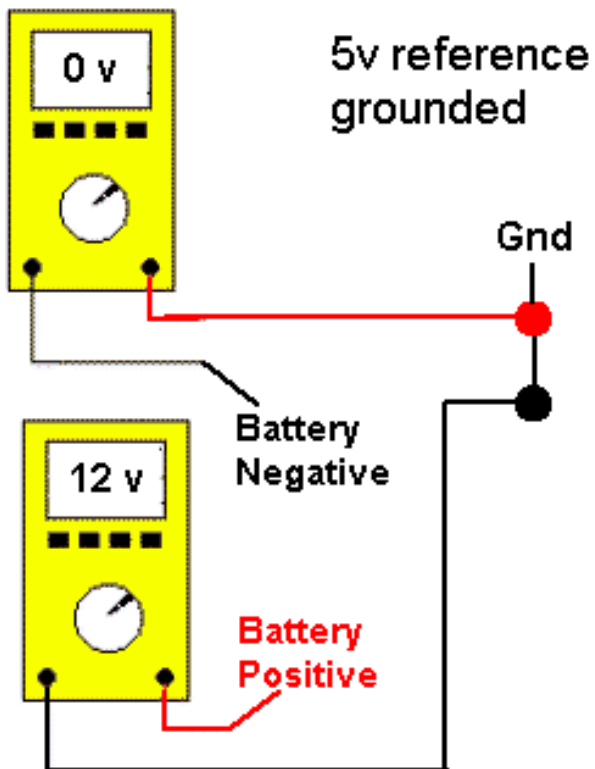
And now with the 5v circuit grounded (as originally thought) the meters read the same.
