DT466E Fuel System

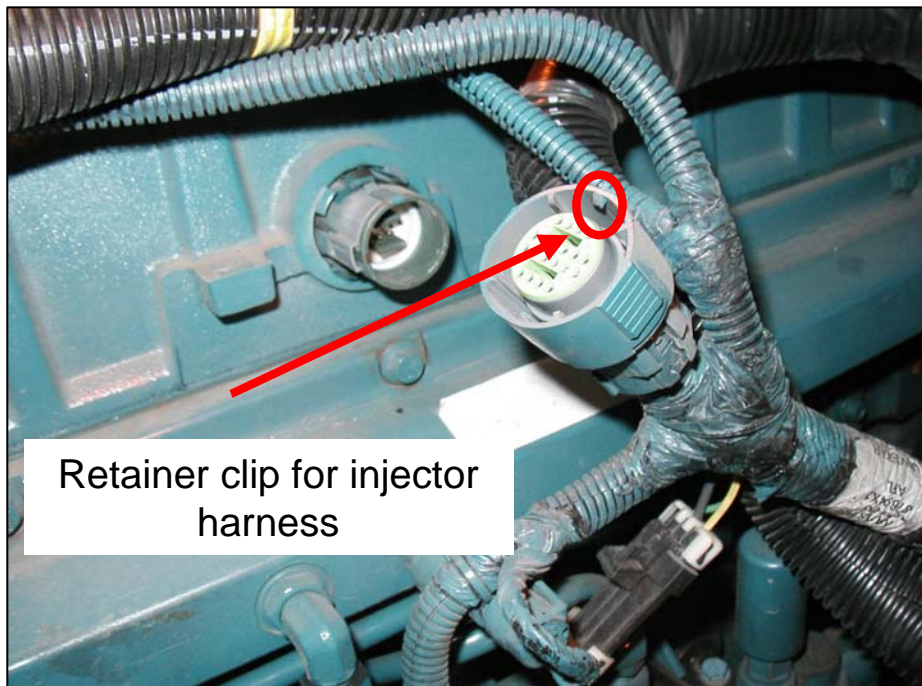
Retainer clip for injector harness

This o-ring will need replacement when a valve cover is removed. Squeeze sides of harness to release. Don't break the retainer clip for the harness plug or a new harness will be needed. Oddly enough, complete engine wiring harnesses are not expensive.
